## **Comparative prooftesting of breakdown aids Premium Seal Repair compared with latex products**

DEKRA Automobil GmbH

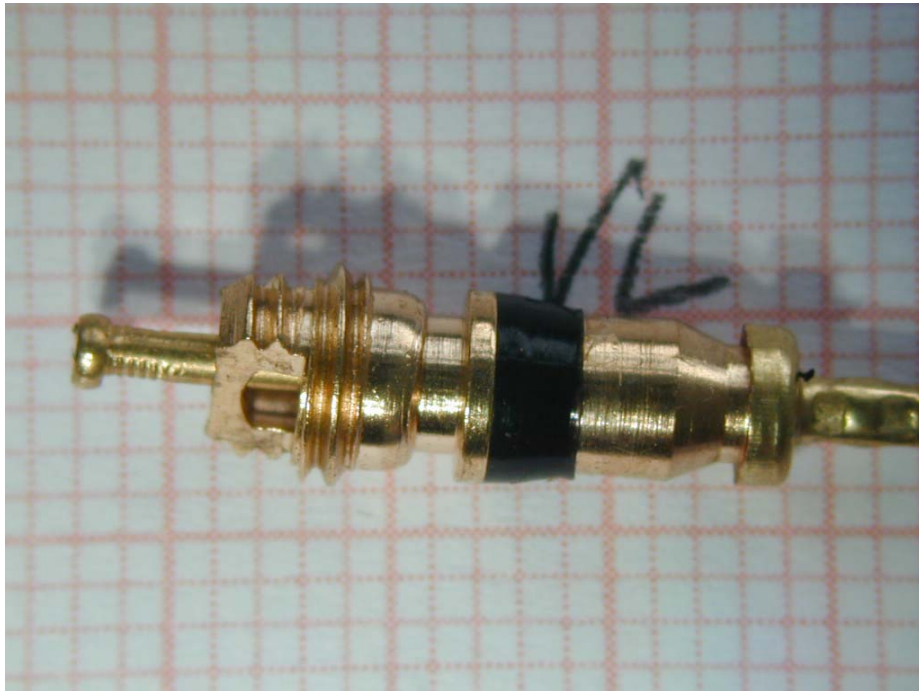
At the tyres treated with Premium Seal Repair were as well front left as rear left no residues or deposits of the sealing means at the valve insert and on the sealing surfaces of the valve insert detectable (Fotos 66 und 67).

This is apparently due to the relative high viscosity of the sealing means Premium Seal Repair which does not deposit from the inner side on the valve inserts.

**Bild 66: With PREMIUM-SEAL Repair there are no residues or deposits of sealing means detectable.**

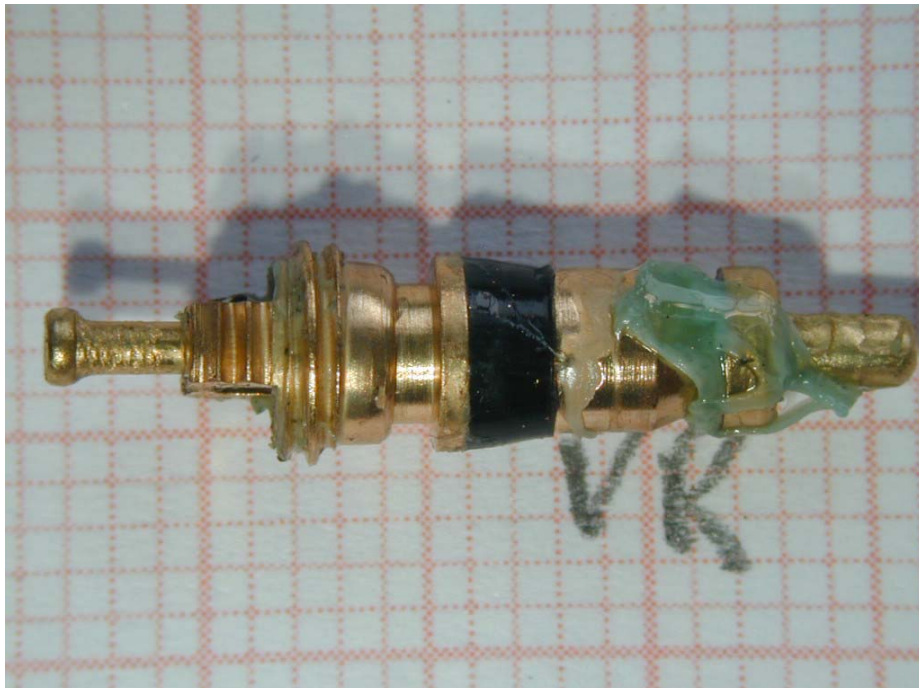
Contrary to that at the latex sealing means front right and rear right (Dunlop and Continental) significant deposits and residues of the tyre sealing means in dried and numbed form were detected under the microscope at the sealing surfaces of the valve (Fotos 68 und 69).

From the experience of examinations of different tyre defects in the past (mainly with motor cycles where tyre sealing means based on latex are preferably used) it is to mention that such residues of sealing means at the valve insert partly lead to slight leakages and creeping pressure drop with significant detraction of the road performance of the car and following accidents.

This leads to the conclusion that from the expert point of view the filling of latex products in case of a break down without removing the valve insert may lead to leakage problems at the valve insert.

**Bild 68: With latex products there are heavy deposits and residues of sealing means detectable.**
