# Comparative Test

PREMIUM-SEAL *Repair* /  
Latex breakdown aids

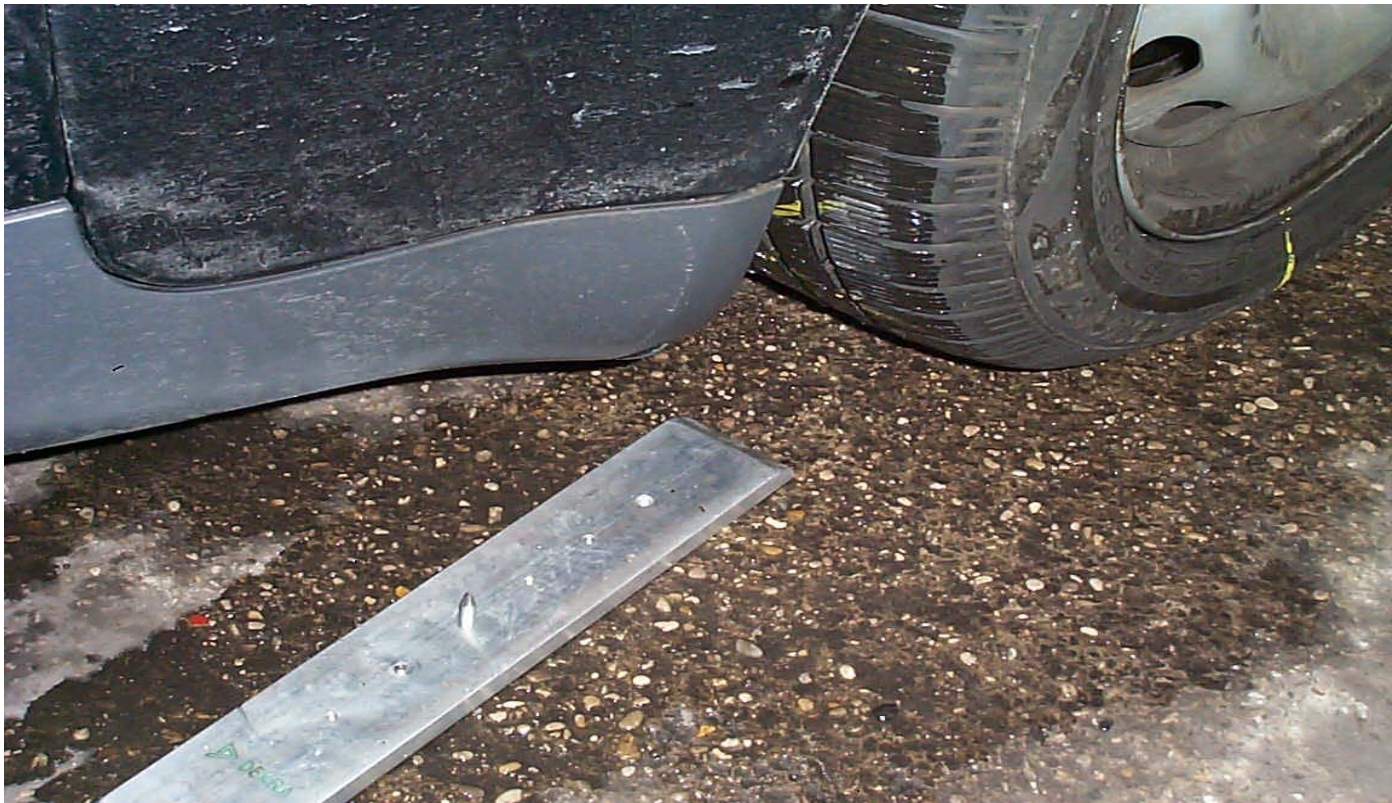
- Nail bolt Ø 6 mm run in with total loss of pressure

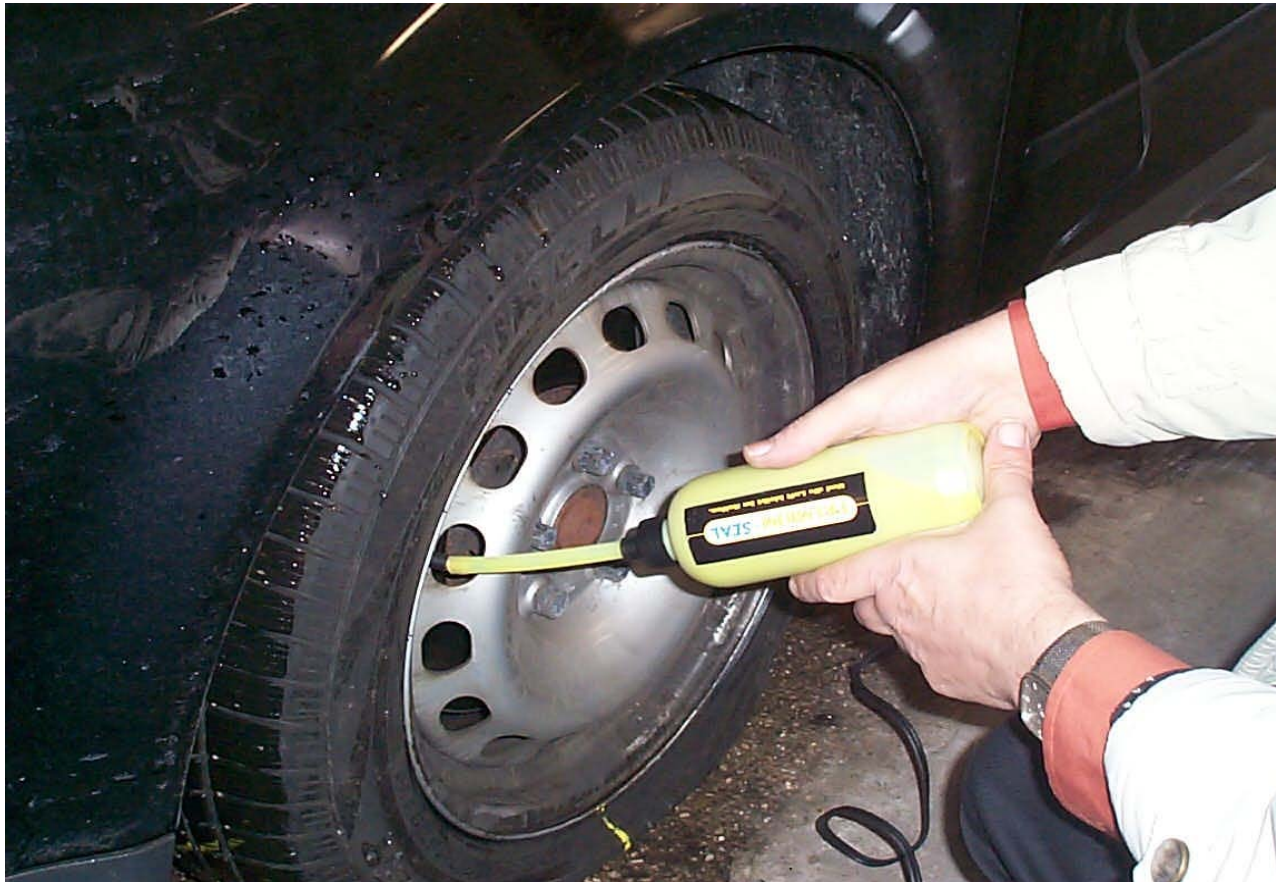
Clearing of the „breakdown“ at the left tyre: PREMIUM-SEAL *Repair*

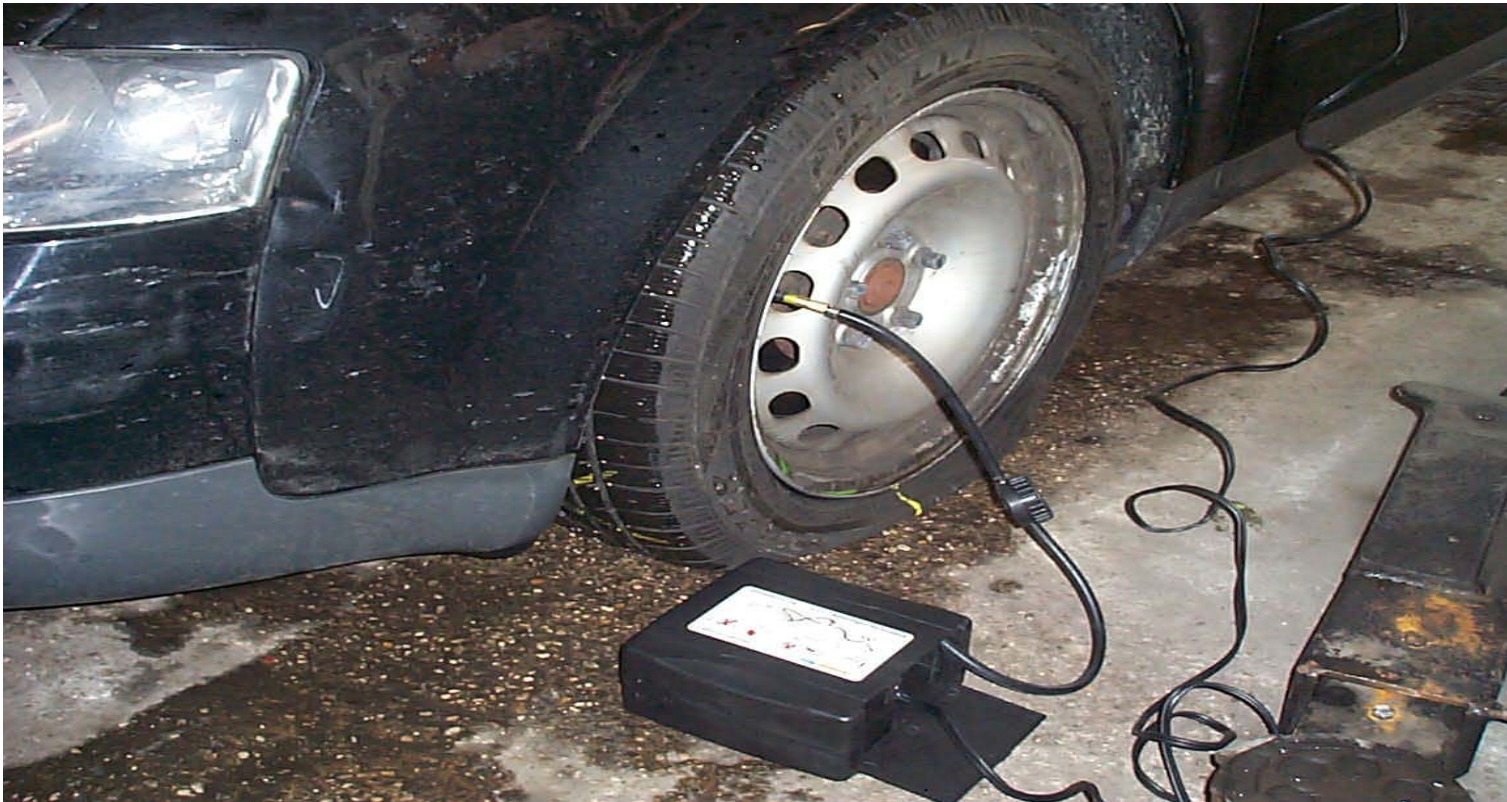
Pumping up the tyres with 12V Kompressor to 2,5 bar

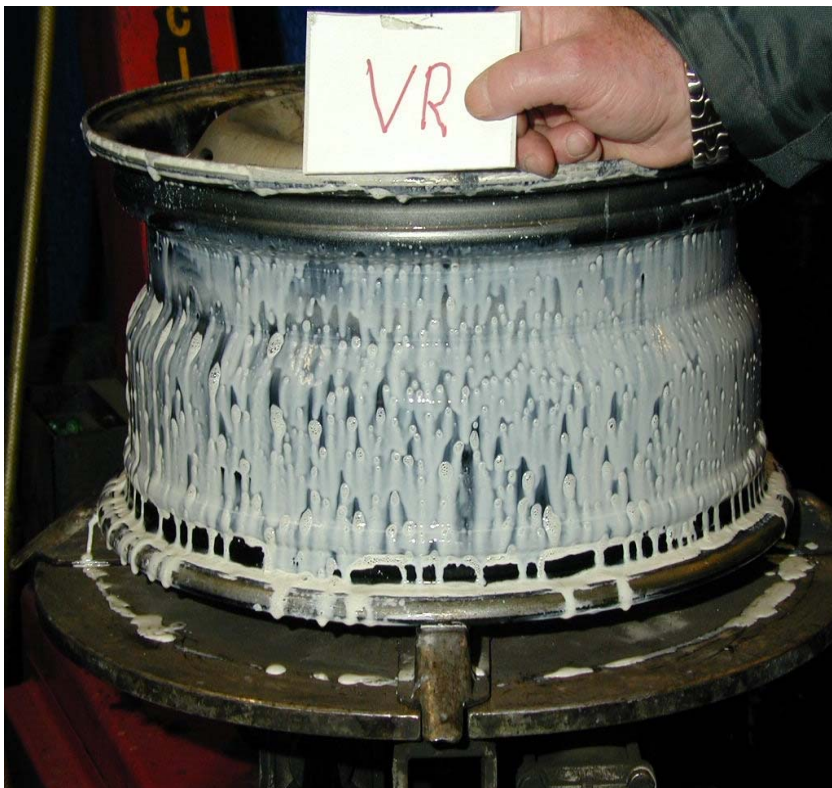
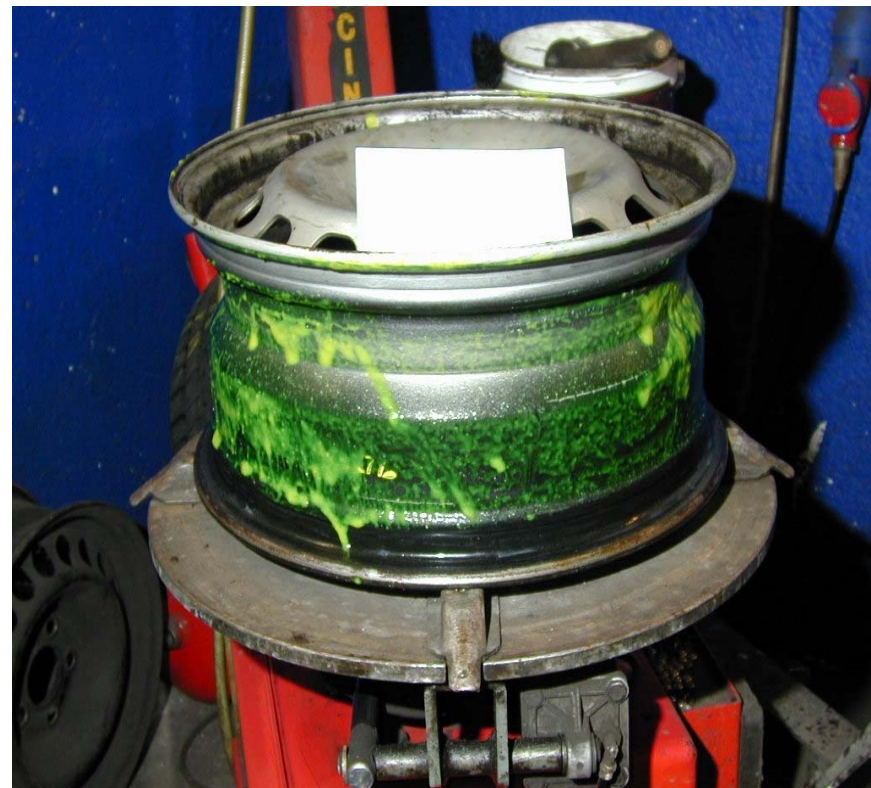
Cleaning of all tyres and rims after test drive and disassembly with paper towel and water

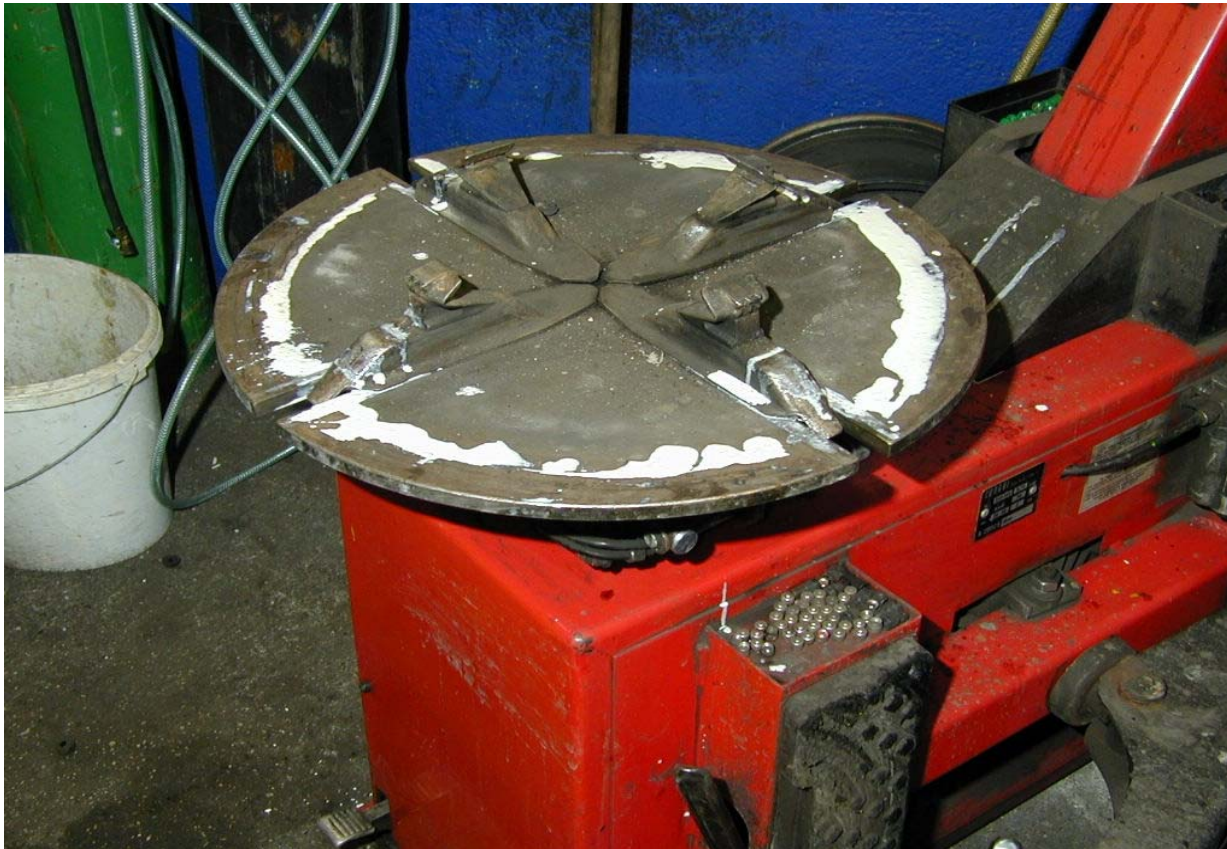
Soiling of mounting machine with latex

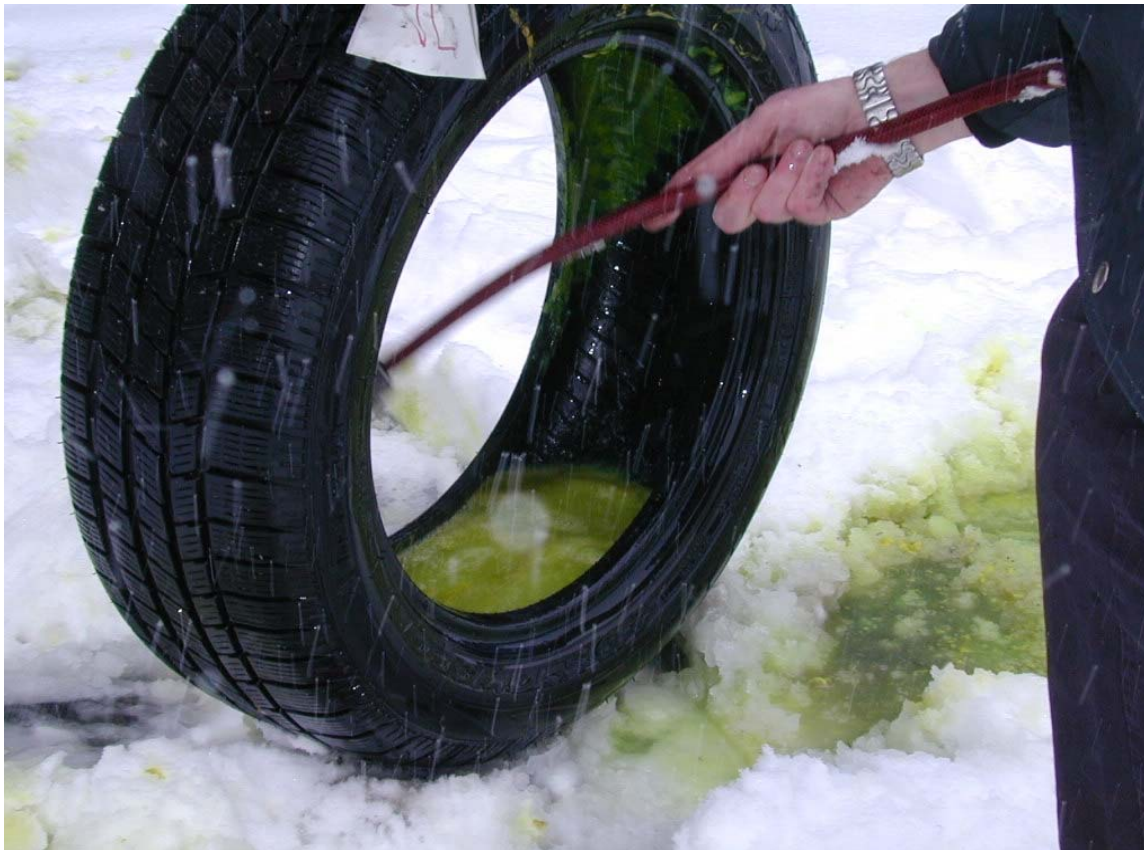
Cleaning the tyre with water

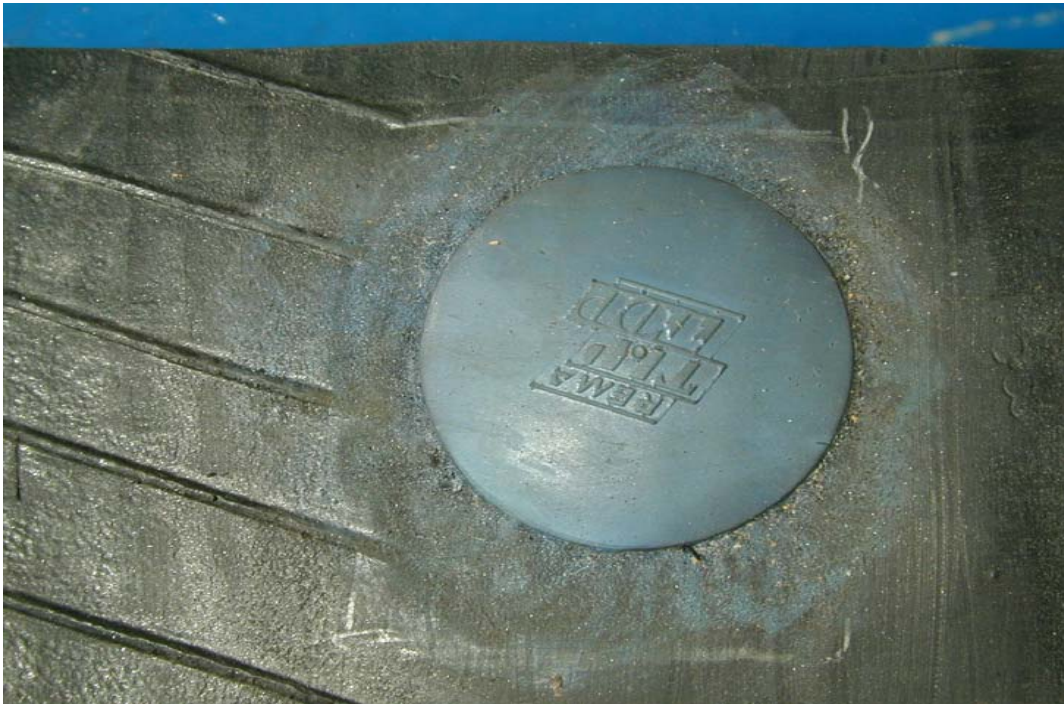
The tyre was professionally repaired with a Minikombi A6 at Stahlgruber

View at the inner tread

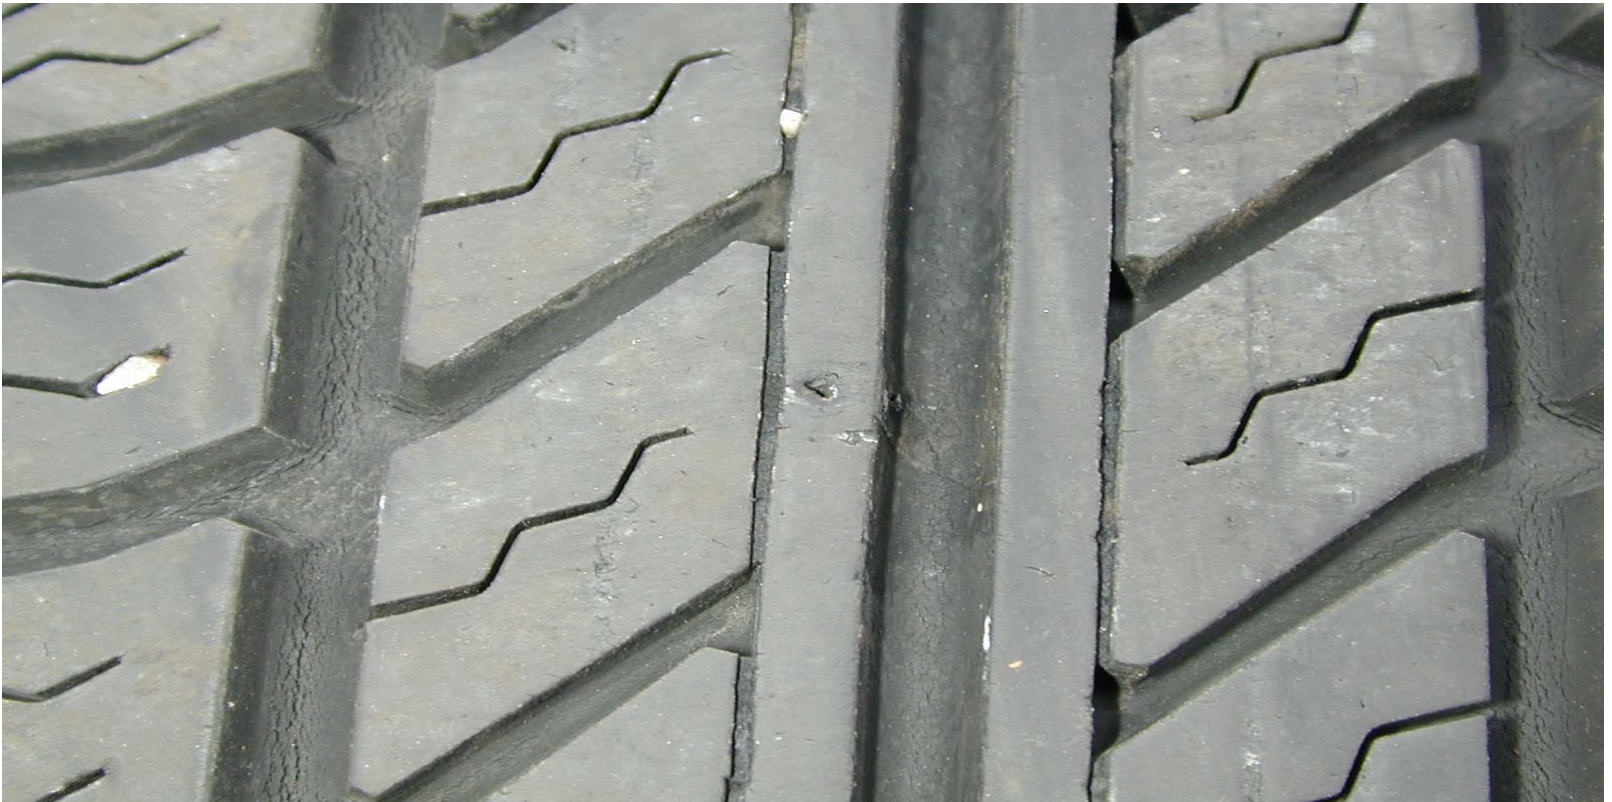
The tyre treated with PREMIUM-SEAL *Repair* and repaired passed all stages without any problems

View at the puncture from the outside

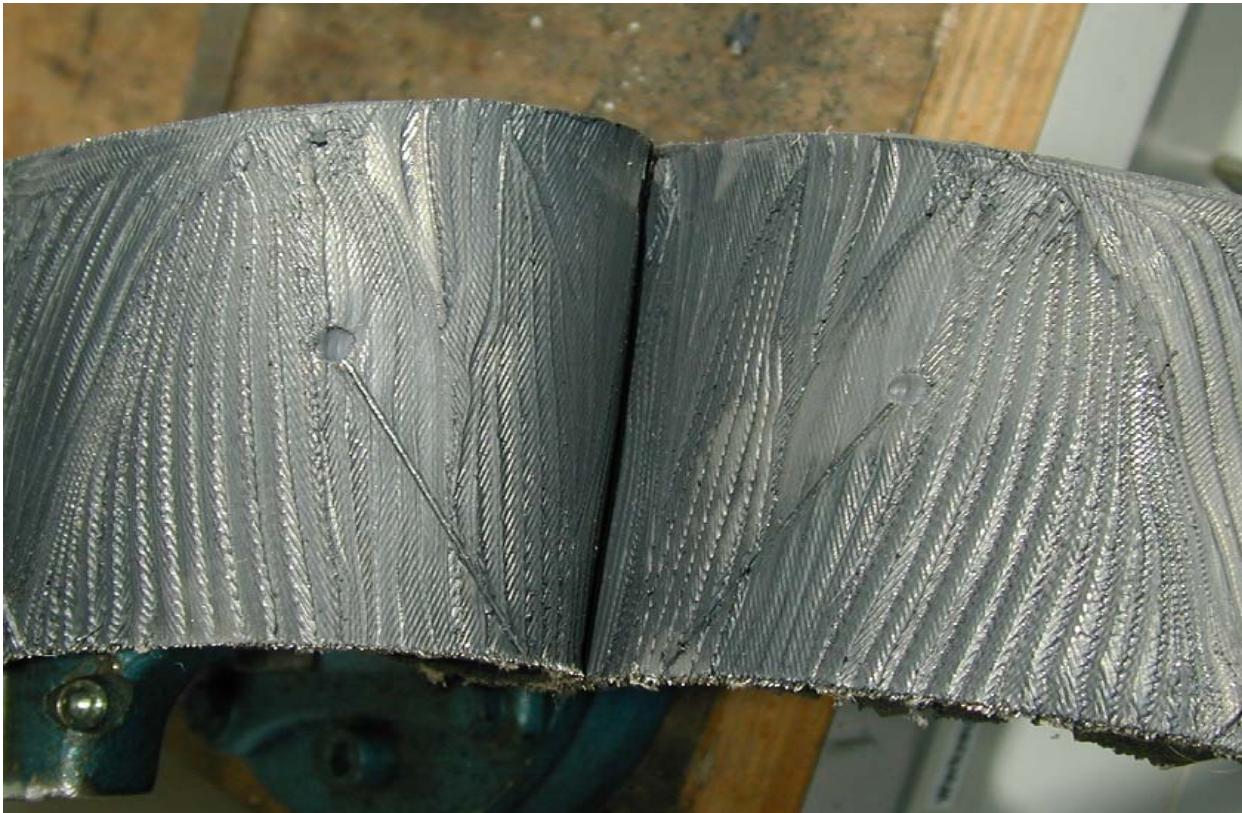
Repair location after dissection

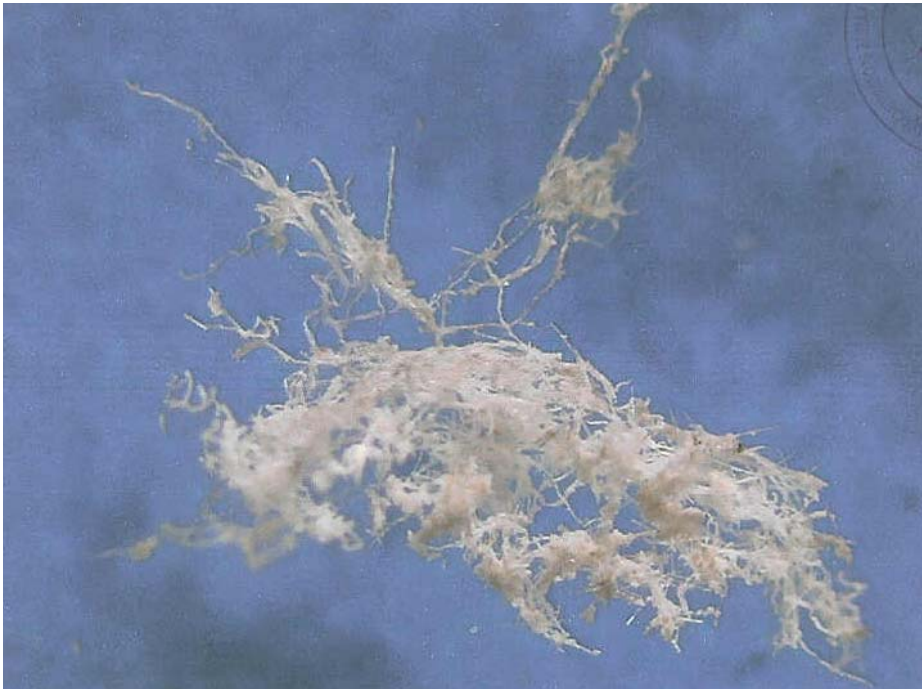
Microfibers at PREMIUM-SEAL *Repair*

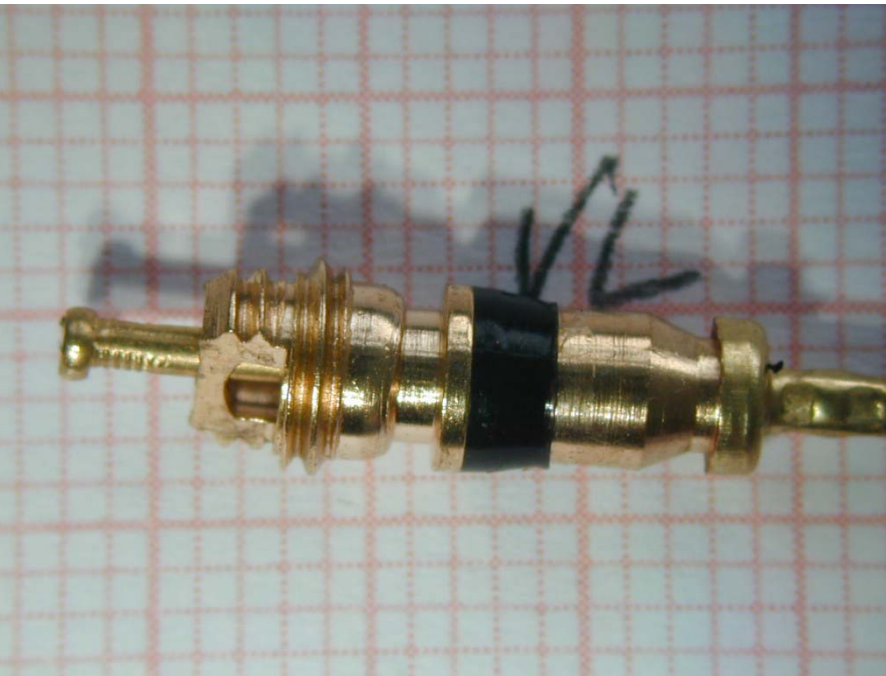
State of the valve insert

PREMIUM-SEAL *Repair*  
Without soiling

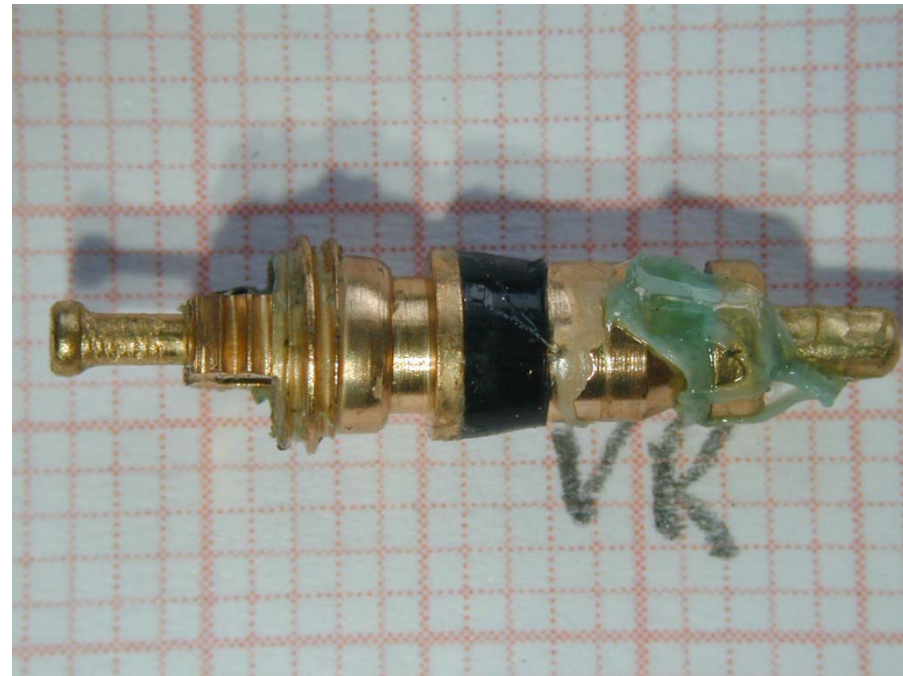
Latex  
Hazard of creeping pressure loss
