Garching, 15.5.2007
Department: TA-DW
1/MUC

Technical report on the tests conducted with Premium Seal Tyre Puncture Systems

Customer: Premium Vertriebs GmbH
Rieslingweg 23
D-74354 Besigheim

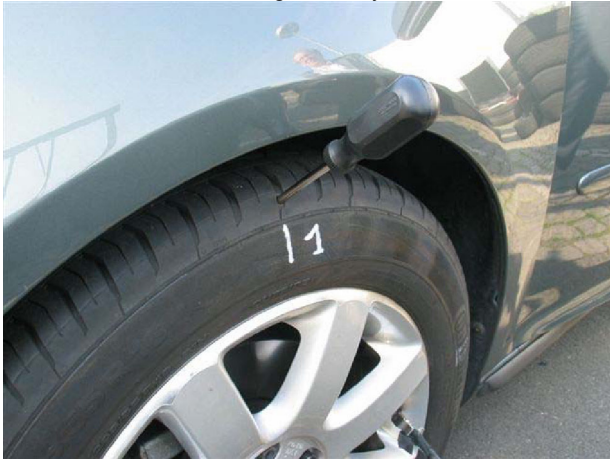
Damage to the tyre

The damage was simulated on the shoulder (protector run) with a spike driven in, with a diameter of 6 mm.

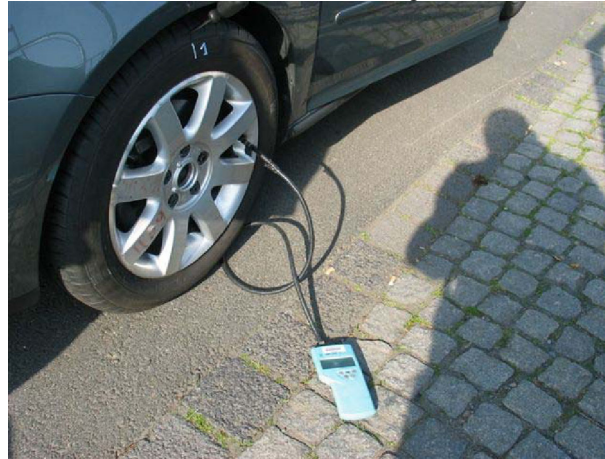
Determination of the leakage rate

The damaged tyre was subjected to a tyre filling pressure of 2.5 bar.

The leakage rate was established when standing (*measurement device DPI 705*).

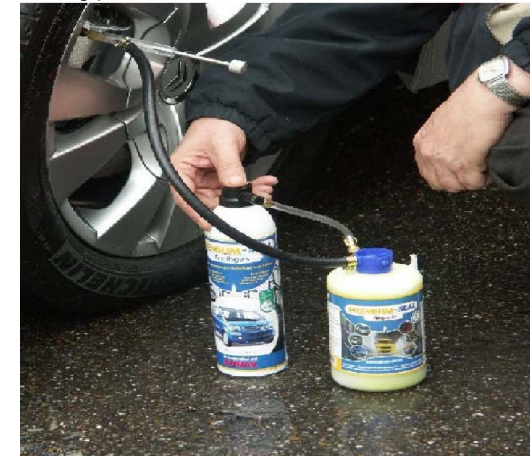
Filling process with AIO aerosol and comfort bottle

The pressure increase occurred in Experiments 1 and 3 by means of PREMIUM-SEAL AIO, Type aerosol, fill quantity 500 ml.

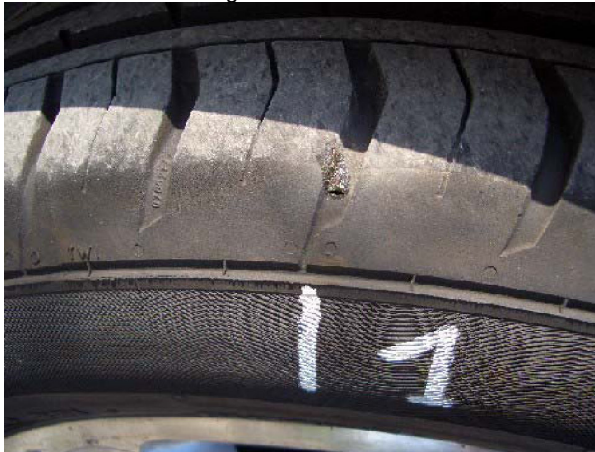
Damage sealed after 10 km

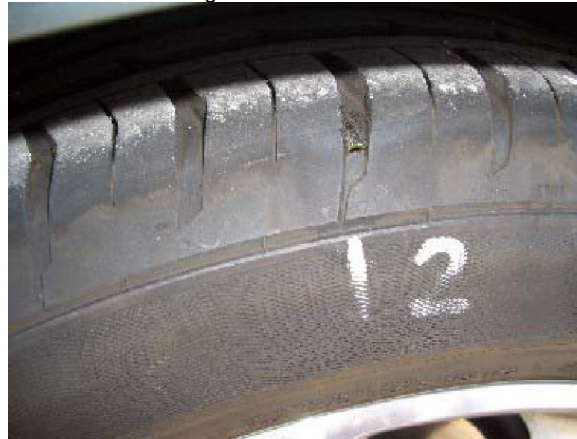
Damage not sealed after 10 km

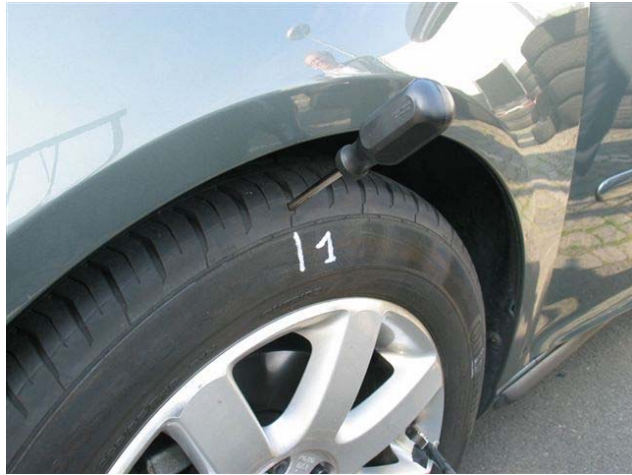
Schädigung des Reifens

Die Verletzungen wurden an der Schulter (Protectorauslauf) mit einem eingeschlagenen Dorn, Durchmesser 6 mm, simuliert.

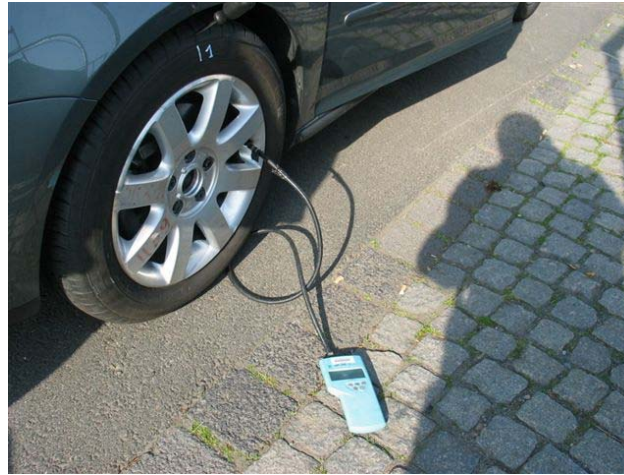
Ermittlung der Leckagerate

Der beschädigte Reifen wurde mit einem Reifenfülldruck von 2,5 bar beaufschlagt.

Die Leckagerate wurde im Stand (*Messgerät DPI 705*) ermittelt.

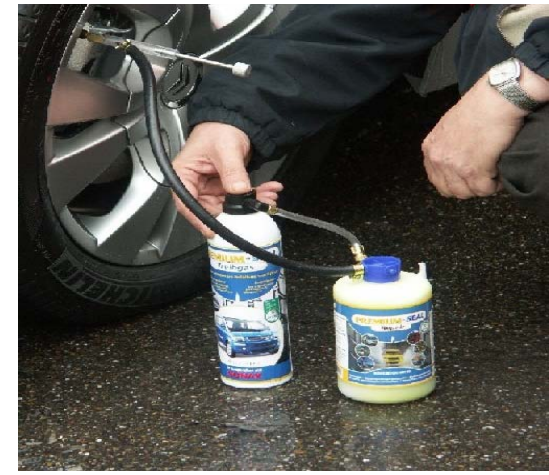
Einfüllvorgang mit Treibgas und Komfortflasche

Der Druckanstieg erfolgte bei den Versuchen 1 und 3 mittels PREMIUM-SEAL AIO, Typ Aerosol Füllmenge 500 ml.

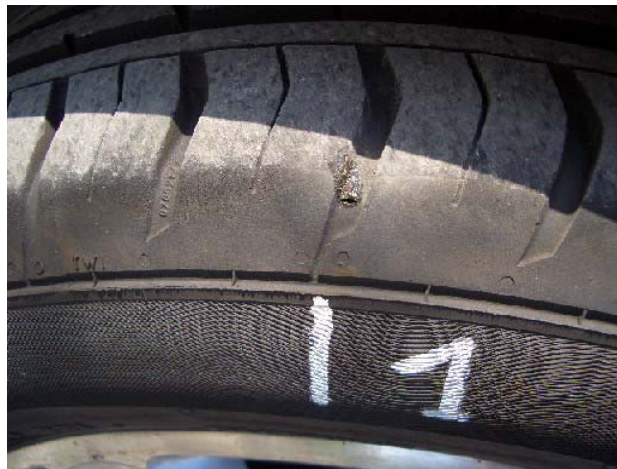
Beschädigung nach 10 km abgedichtet

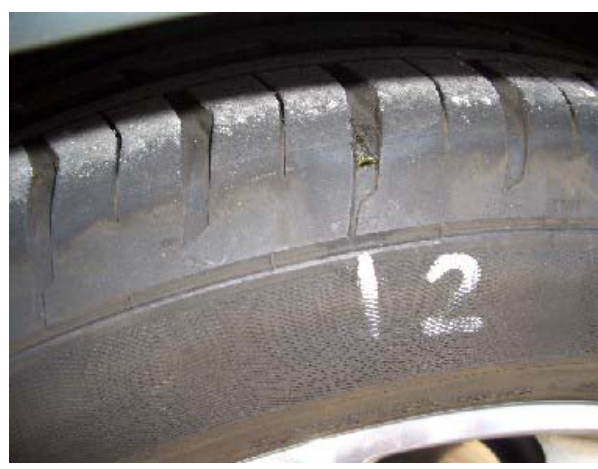
Beschädigung nach 10 km nicht abgedichtet
