## **Technischer Bericht über durchgeführte Untersuchungen an Premium Seal Pannensystemen**

Garching, 08.05.2007

Experimental drives with varying tyre puncture systems with 600 ml fill quantity of the manufacturer Premium Seal in conjunction with tyre size 205/55 R16.  
The tyres used were exclusively new tyres supplied by Volkswagen AG, Wolfsburg.

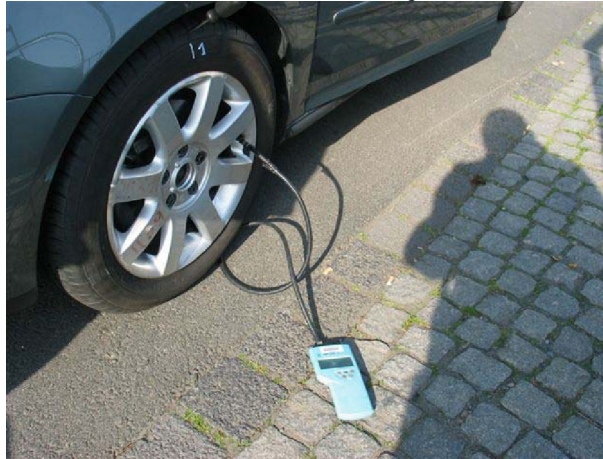
Determination of the leakage rate

The leakage rate was established when standing (*measurement device DPI 705*).

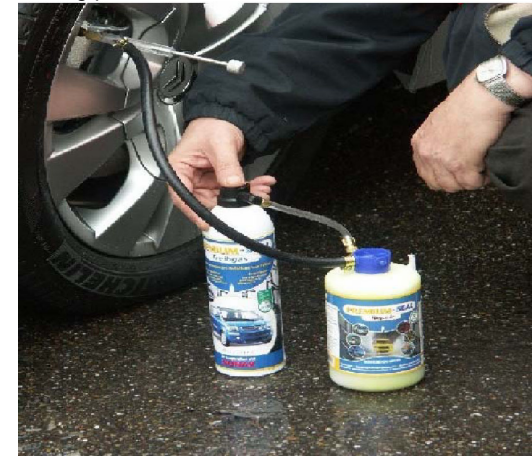
Filling process with AIO aerosol and comfort bottle

The pressure increase occurred in Experiments 1 and 3 by means of PREMIUM-SEAL AIO, Type aerosol, fill quantity 500 ml.

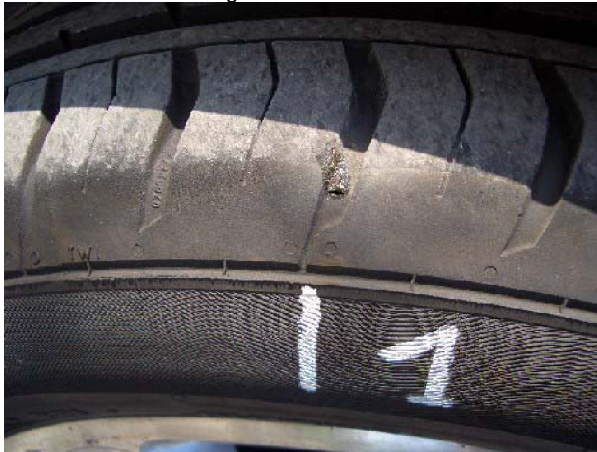
Damage sealed after 10 km

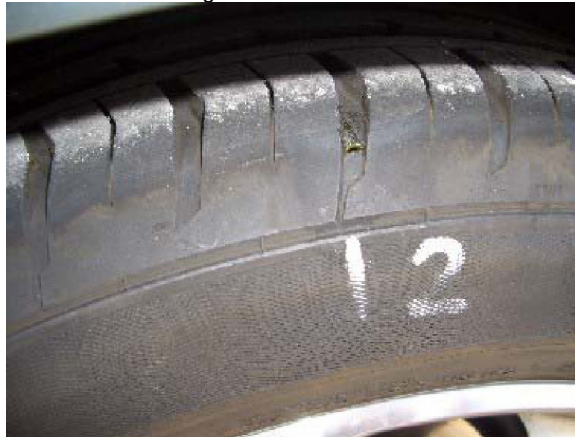
Damage not sealed after 10 km

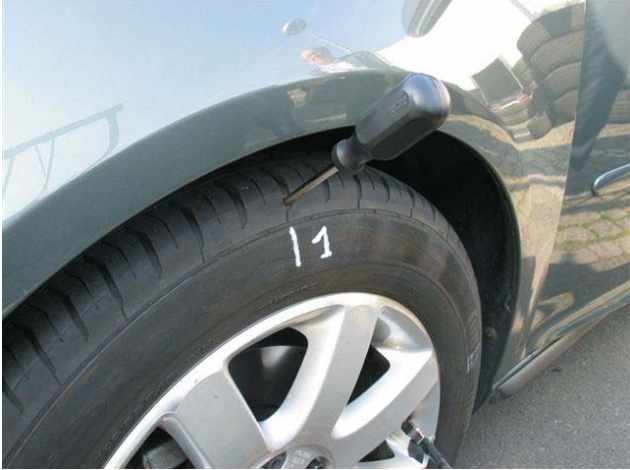
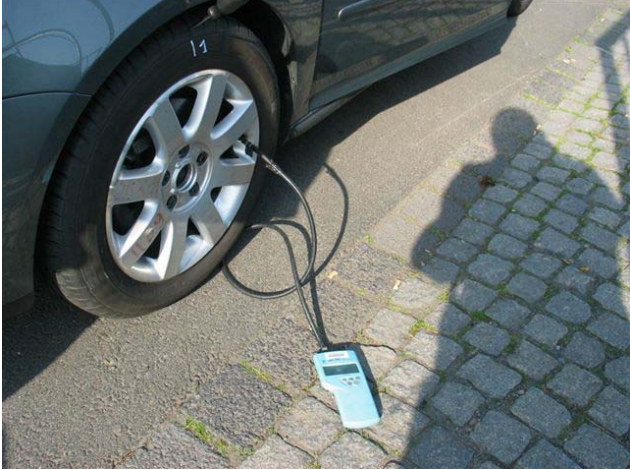
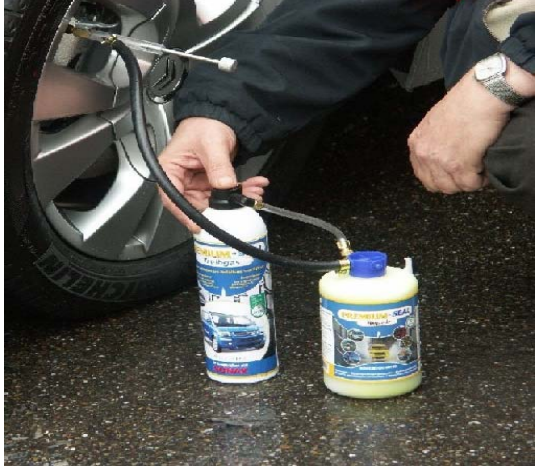
| Schädigung des Reifens | Ermittlung der Leckagerate | Einfüllvorgang mit Treibgas und Komfortflasche |

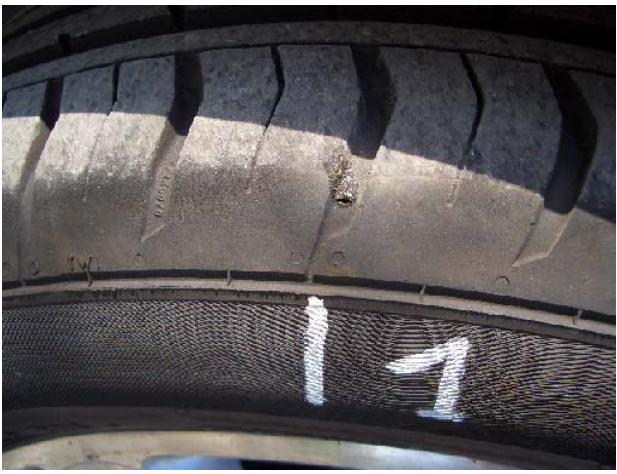
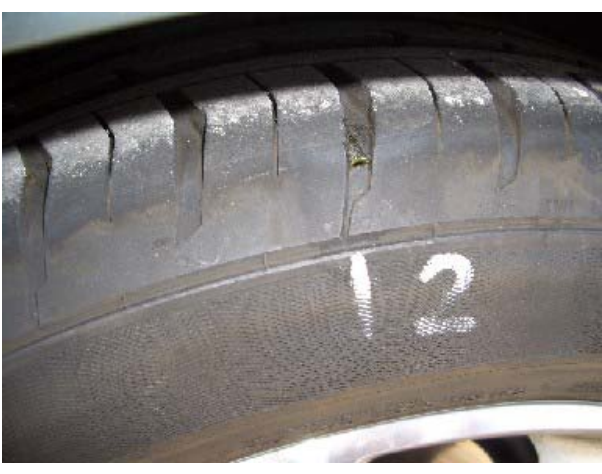
| Schädigung des Reifens | Ermittlung der Leckagerate | Einfüllvorgang mit Treibgas und Komfortflasche |
|---|---|---|
| Beschädigung nach 10 km abgedichtet | Beschädigung nach 10 km nicht abgedichtet | |
