Gutachten-Nr. / Expertise No:
222/0450 702088
1804953921 ha

EXPERTISE

Object: Test of Propellant Bottles for Premium-Seal AIO
with Reference to Thermal Behaviour and
Functionality

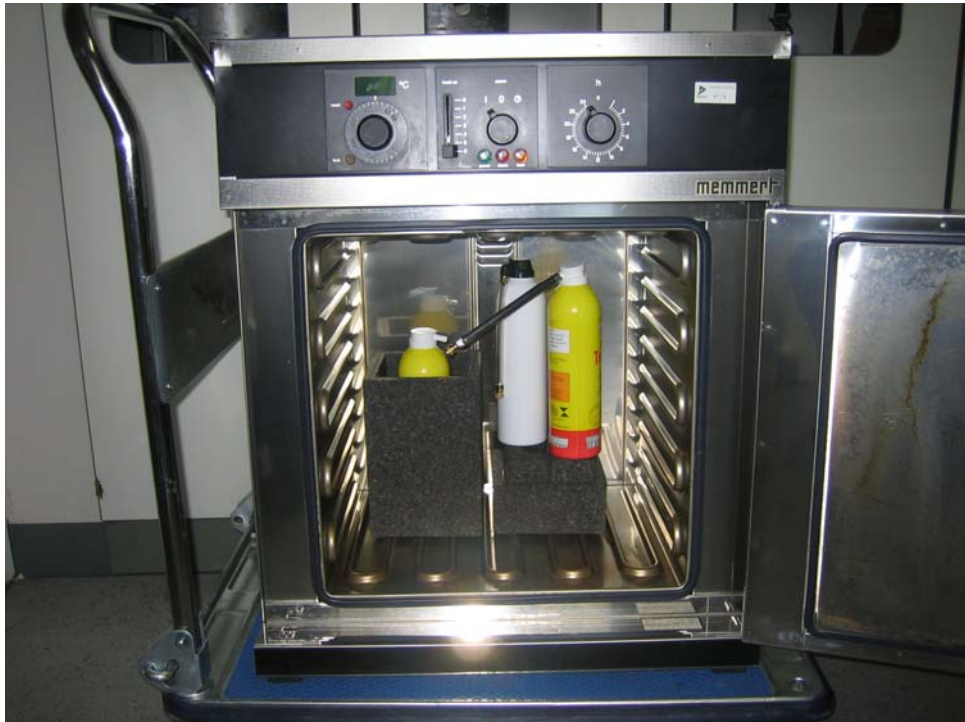
Die Druckgasflaschen wurden bei 80°C im Trockenschrank 24h gelagert.

After 24 hours of conditioning at 80°C a gas pressure of 18 bar at the white propellant bottle and a gas pressure of 20 bar at the yellow propellant bottle have been measured.

The transparent filling-hose of the white bottle burst at 18 bar. The hose connection disconnected from the spray nozzle of the yellow bottle at 20 bar.

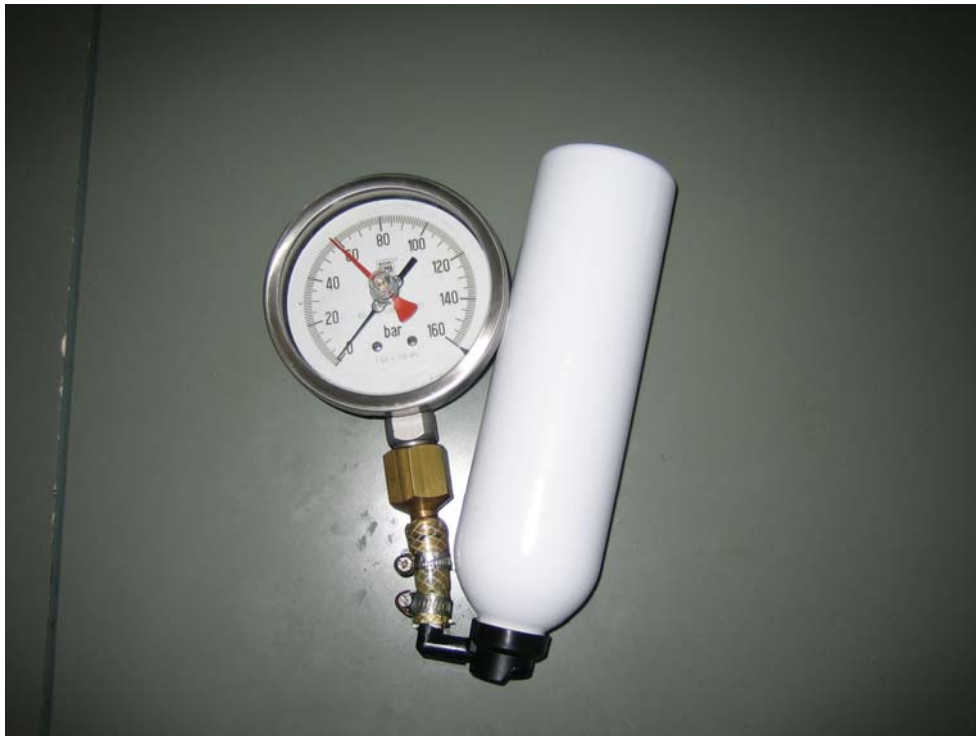
Anschließend wurde der Sprühkopf mit einem Manometer verbunden und der Druck bei 80°C gemessen.
